Manhole Inspection Summary

Manhole # S35II_044MH

Insp Date: **3/14/07 10:13 AM**

Location Address: **1700 LATROBE ST**

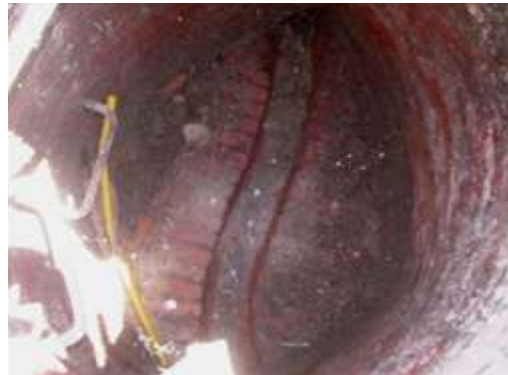
Top View

Evidence of surcharge - Bench debris.

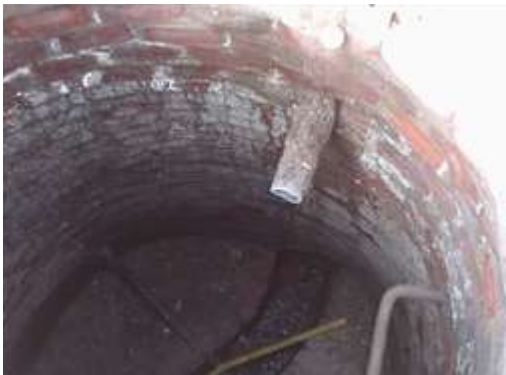
Defect

Infiltration: ☐ None ☒ **Joint** ☐ Cracks ☒ **Mortar** ☐ Roots ☐ Wall

Infiltration: ☐ None ☐ Joint ☐ Cracks ☐ Mortar ☐ Roots ☒ **Wall**

Adjustment, Corbel and Barrel infiltration.

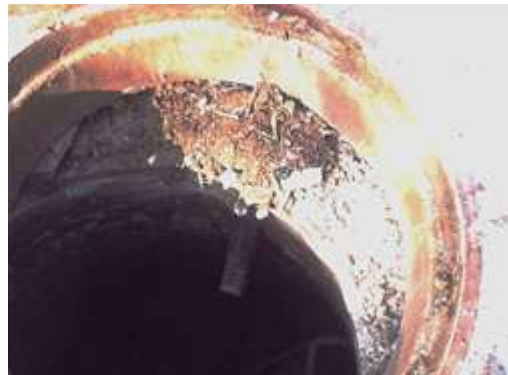
Defect

Comments **Major frame offset. An unknown pipe/valve is coming into the MH through the Corbel.**

Frame Offset: **7** (in.) Condition: ☐ Sound ☐ Cracked ☒ **Leaks**

Condition: ☐ Sound ☐ Cracked ☐ Root Intrusion ☐ Loose Brick ☒ **Deteriorated**

Frame leaks. Frame offset. Adjustment deterioration and infiltration.

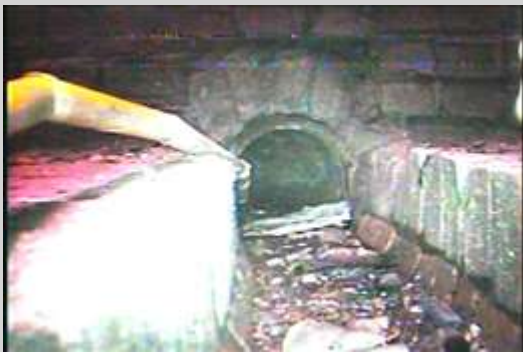
8 in. Circular Gravity Sewer Pipe Out @ 12 O'Clock

Barrel deterioration and infiltration.

Deposits: ☐ None ☒ **Mud** ☐ Sludge ☒ **Debris** ☐ Grease

Silt Depth: **2** (in.) Deposits Extent: **Light**

Infiltration: **Evidence** Pipe Seal Cond: **Unknown**

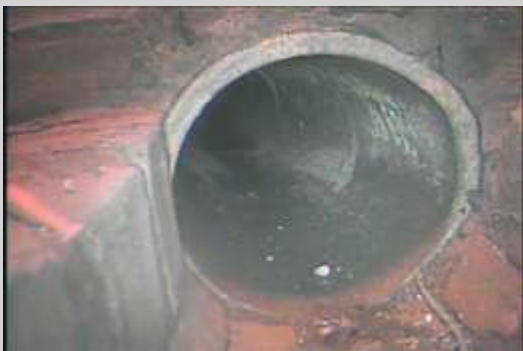
8 in. Circular Gravity Sewer Pipe In @ 6 O'Clock

Deposits: ☐ None ☒ **Mud** ☐ Sludge ☐ Debris ☐ Grease

Silt Depth: **0.5** (in.) Deposits Extent: **Light**
